FRETTING RESISTANT COATINGS FOR TITANIUM ALLOYS

D.J. Padberg
McDonnell Aircraft Company

TECHNICAL REPORT AFML-TR-71-184

SEPTEMBER 1971

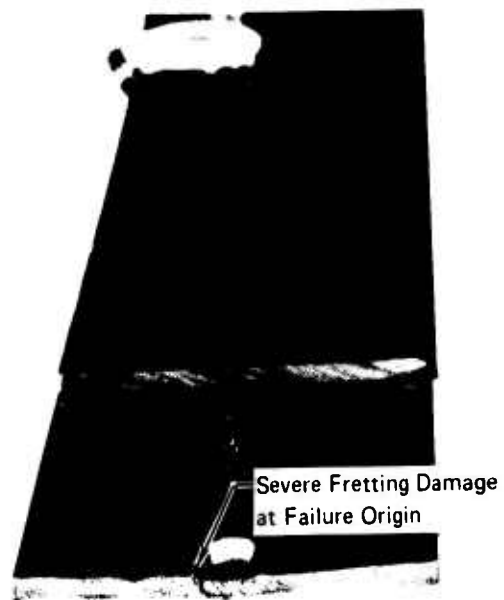
Figure 1 Fatigue Failure Due to Fretting Damage

Early MCAIR investigations showed that fretting must be taken into consideration as a factor influencing fatigue life. The ultimate severity of fretting damage discovered in those studies is illustrated in Figure 1. The normal point of highest stress concentration on this stringer to rib joint should have been the fastener hole. As evidenced by the fact that the line of failure did not pass through the hole, the fracture originated on the faying surface at the point of fretting damage.

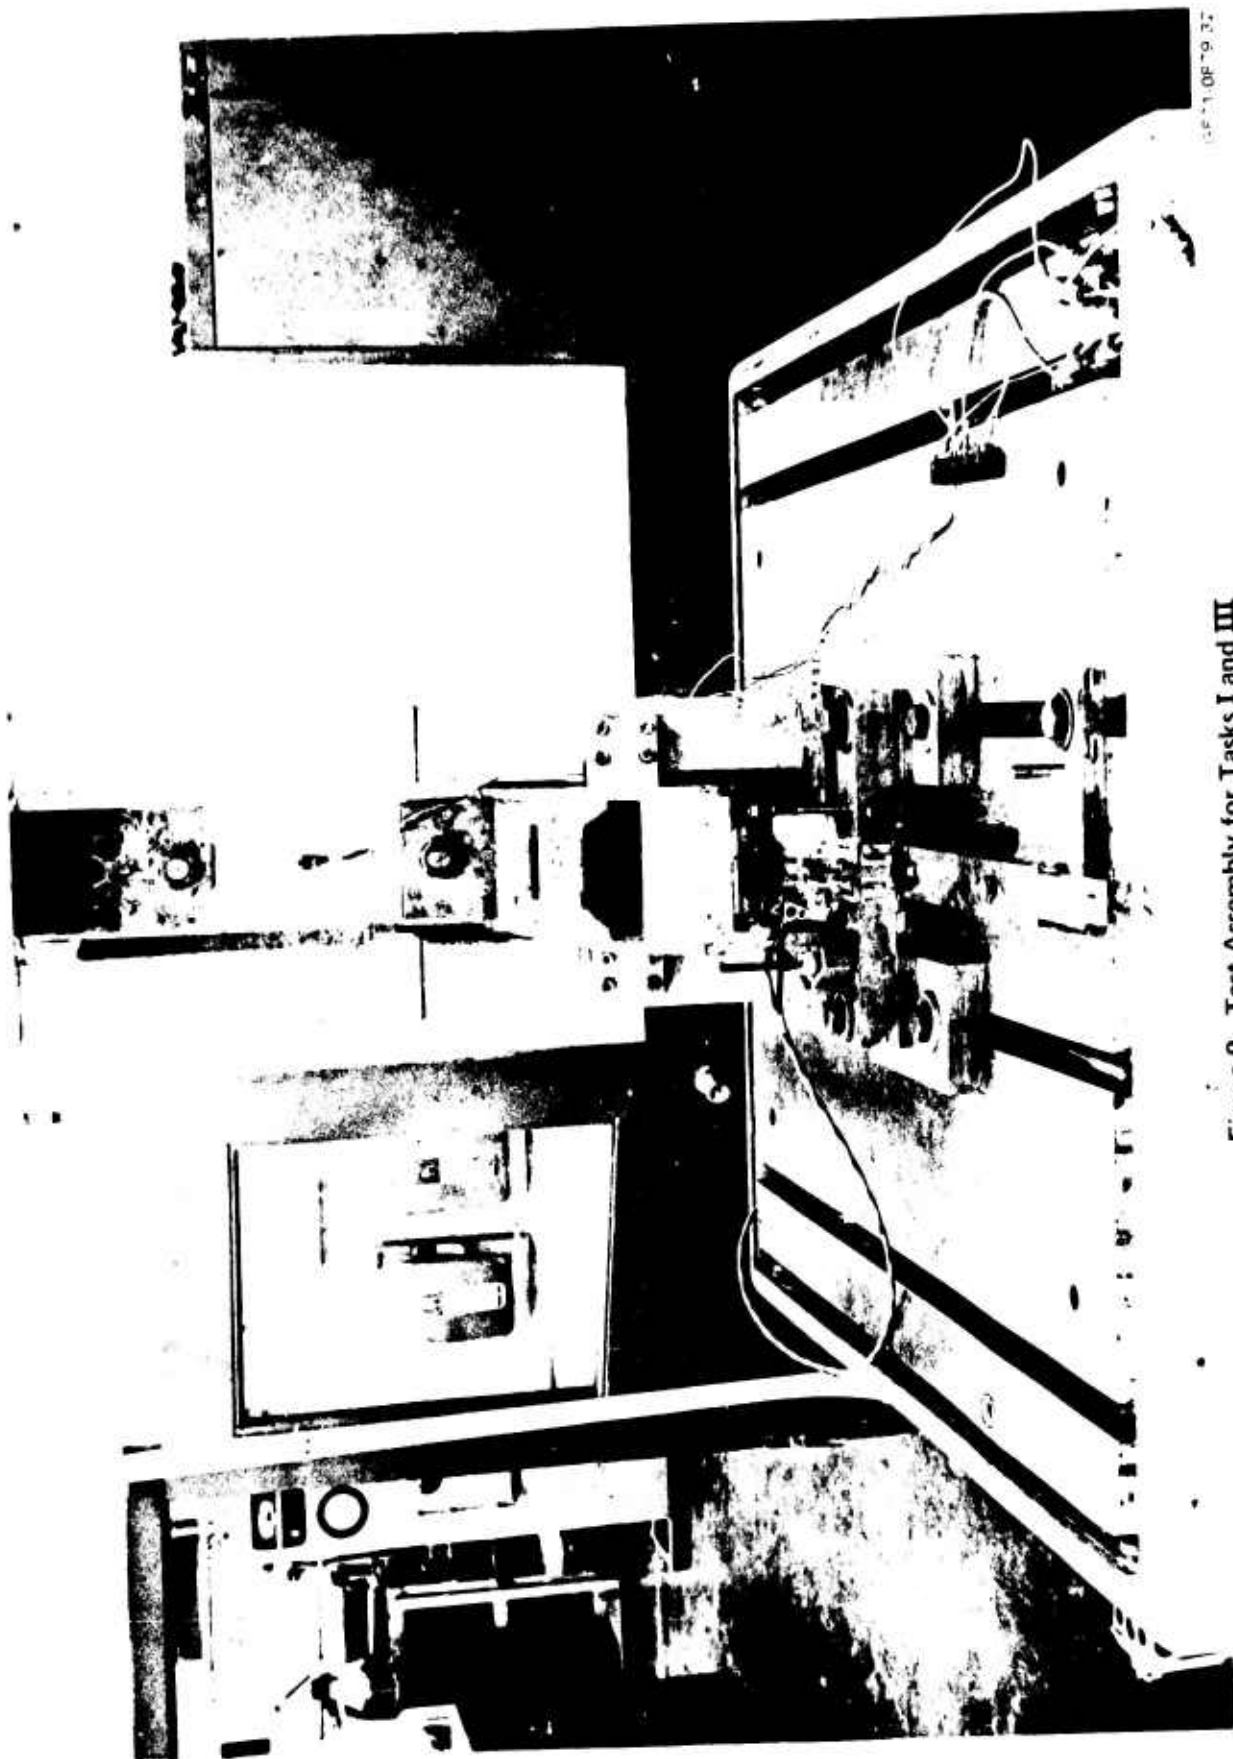
Figure 9 Test Assembly for Tasks I and III

Six preliminary fatigue specimens were tested on the Sonntag SF-10-U fatigue machine fitted with a 5 to 1 load multiplying device and an automatic stop fixture to prevent damage to the fractured surfaces (see Figure 9). Based on the results of testing these six specimens, "low" load was set at 12,000 lb (38,400 psi gross stress) and "high" load was set at 22,000 lb (70,400 psi gross stress). The complete data for the six preliminary specimens (No's A through F) and the remainder of Task I testing is listed in Appendix B.

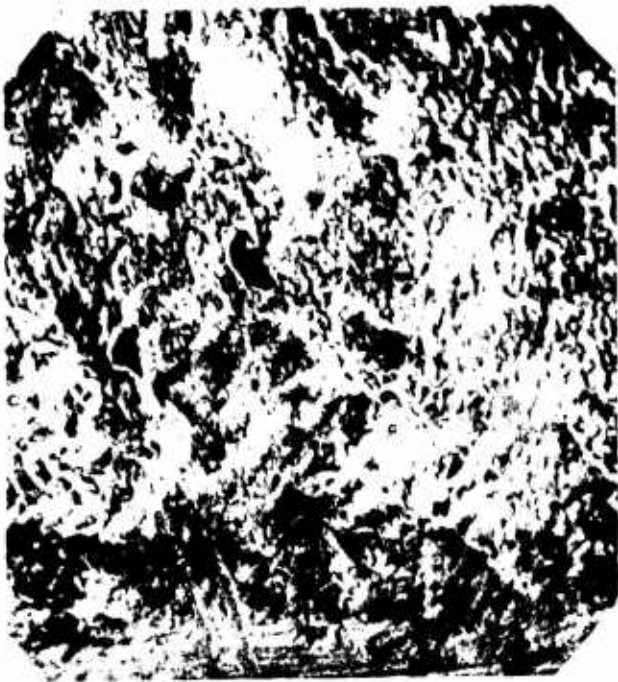
Figure 12 Typical Fretted
Surface SEM Photo 300X

Those specimens with surface fretting damage as the failure origin were examined with the scanning electron microscope (SEM). Figures 12 and 13 show typical fretted surfaces at two magnifications. No detectable differences were observed between fretted surfaces resulting from different joint parameters. Figure 14 is a SEM photo of an unfretted surface.

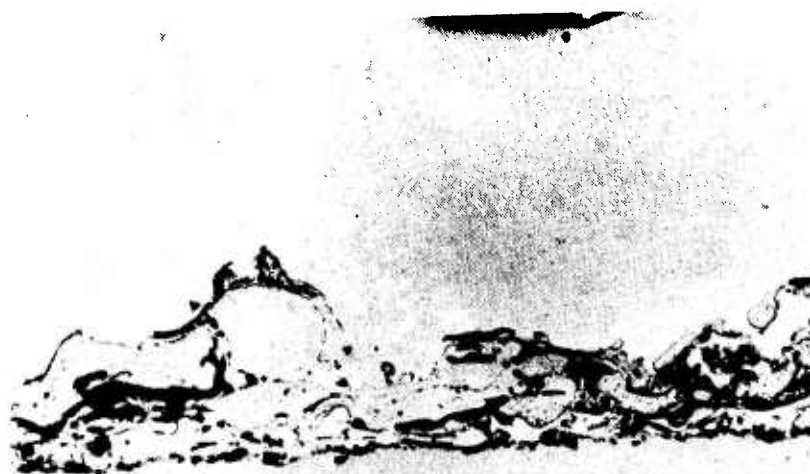
Figure 16 Plasma Gun Sprayed Tungsten Carbide, 250X

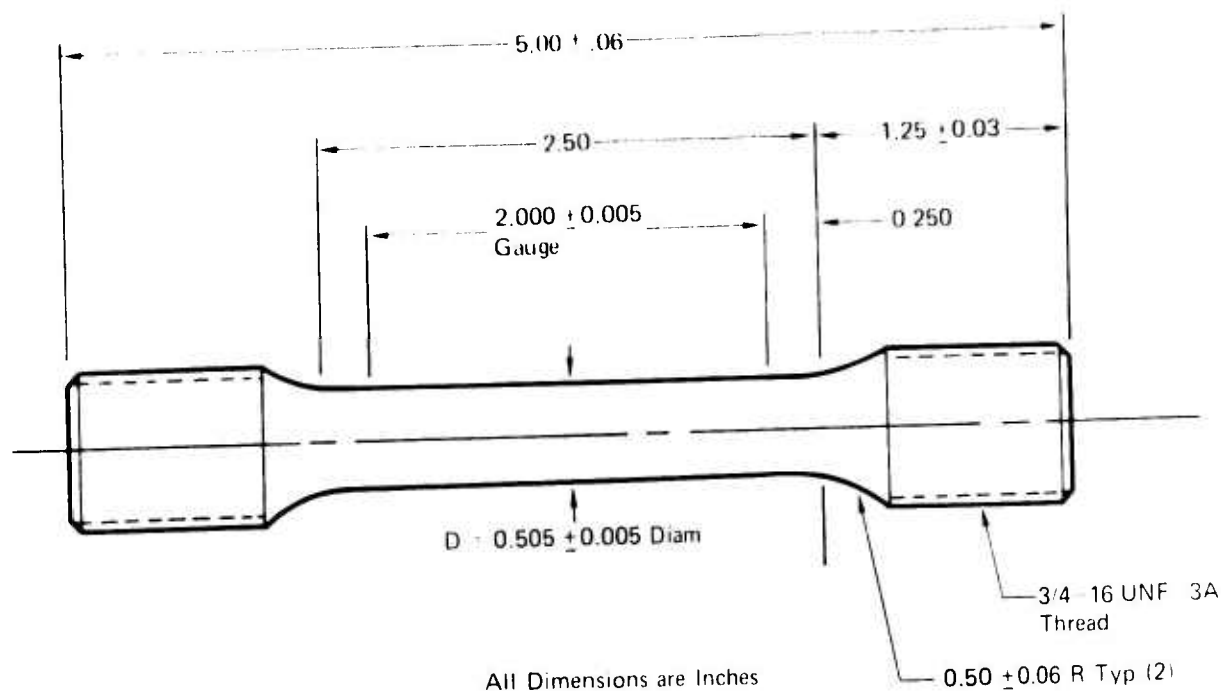
Figure 17 Tensile Specimen - Task II

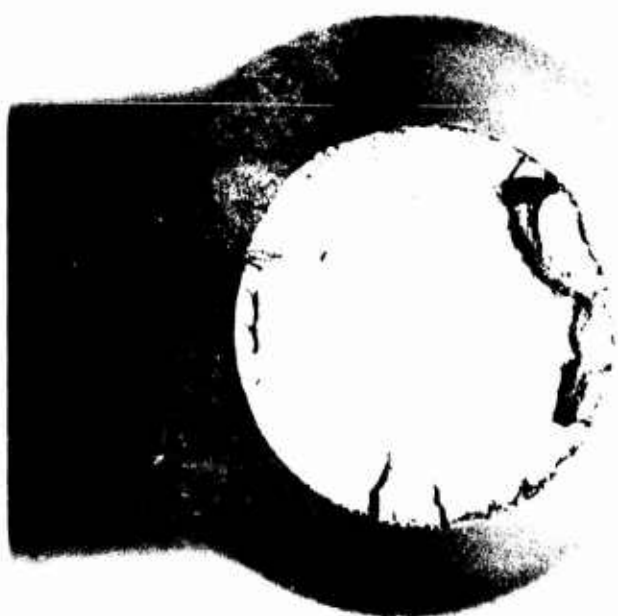
Figure 21 Fracture Surface of Unnotched Fatigue Specimen,
IVD Aluminum Plated and Hardcoat Anodized

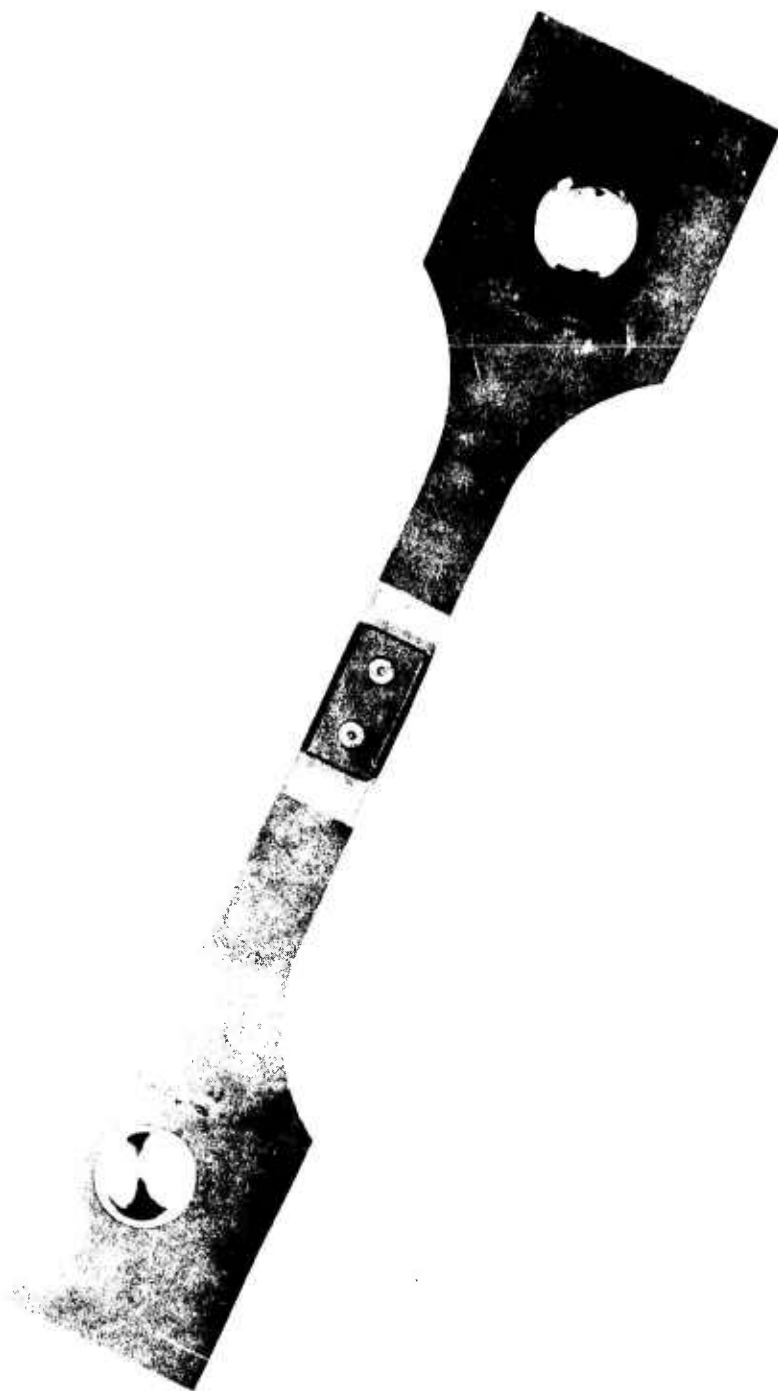
Figure 23 Task III Specimen: Tiodized-Molykote 106 Coated, after Fatigue Test

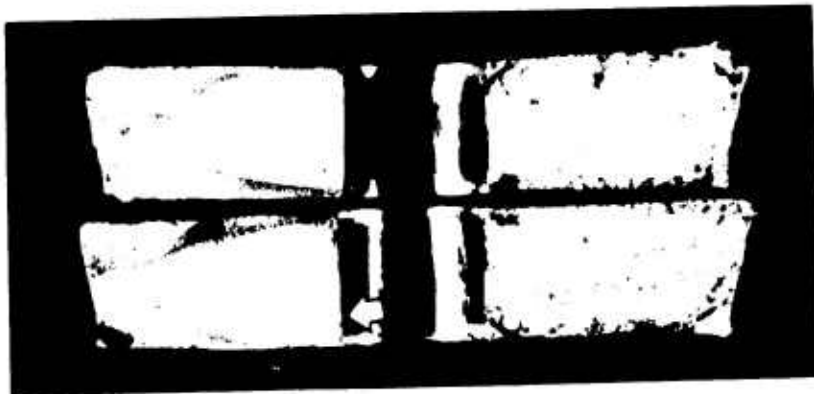
Figure 24 Specimen 5 - Task III

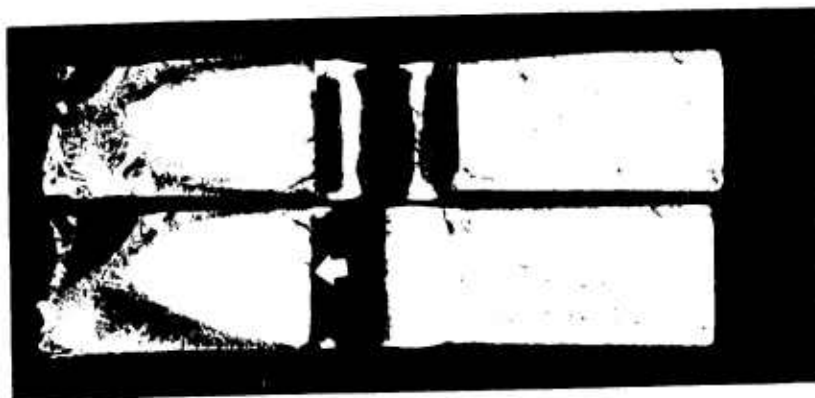
Figure 25 Specimen 12 - Task III

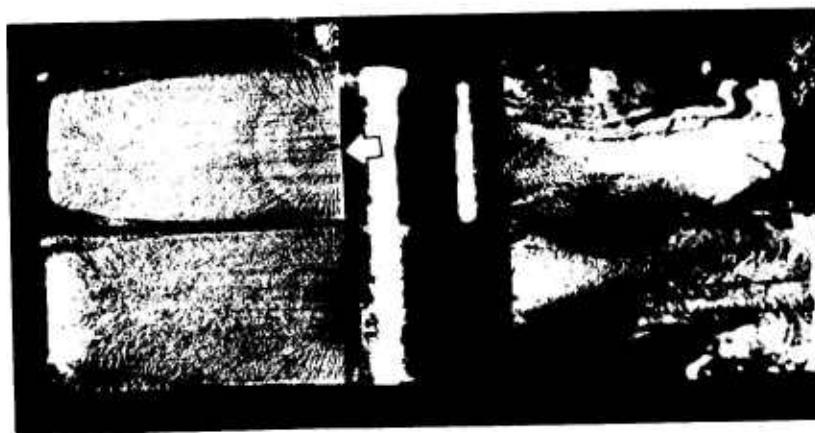
Figure 26 Specimen 17 - Task III

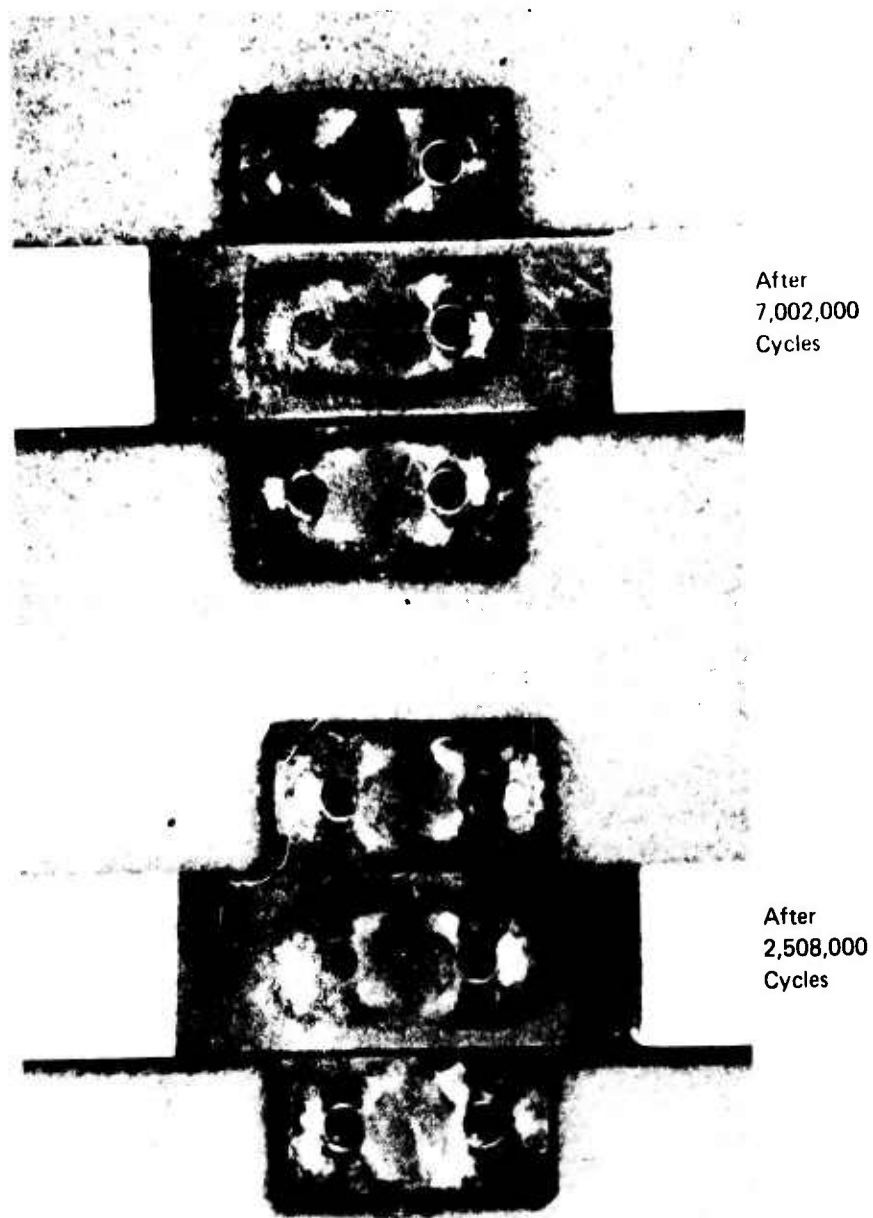
**Figure 27 Gauge Section of Molykote 106 Coated Specimens,
Disassembled after Testing**

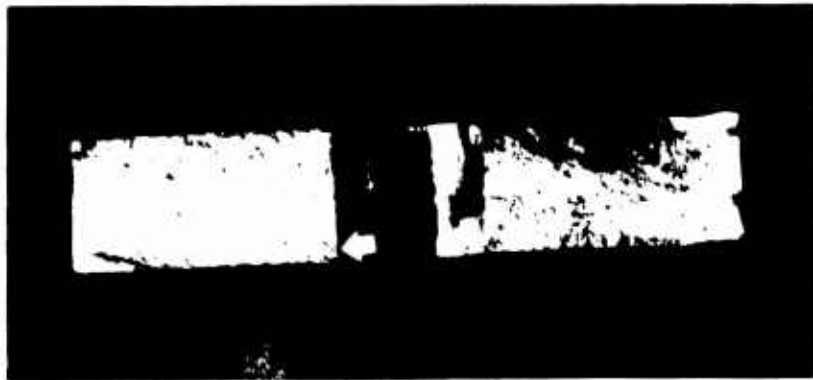
Figure 29 Specimen 24 - Task III

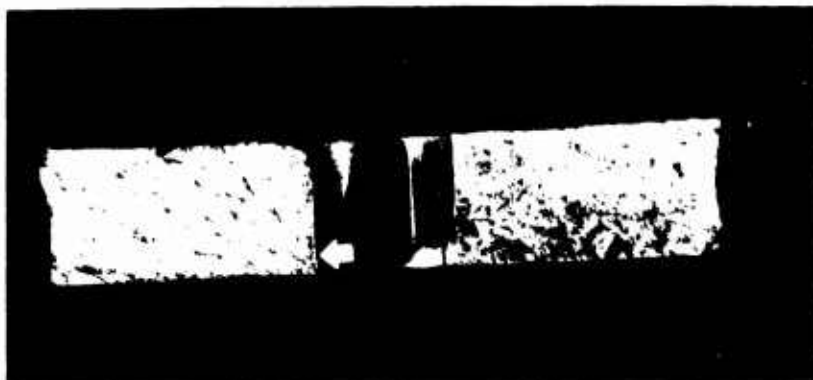
Figure 30 Specimen 25 - Task III

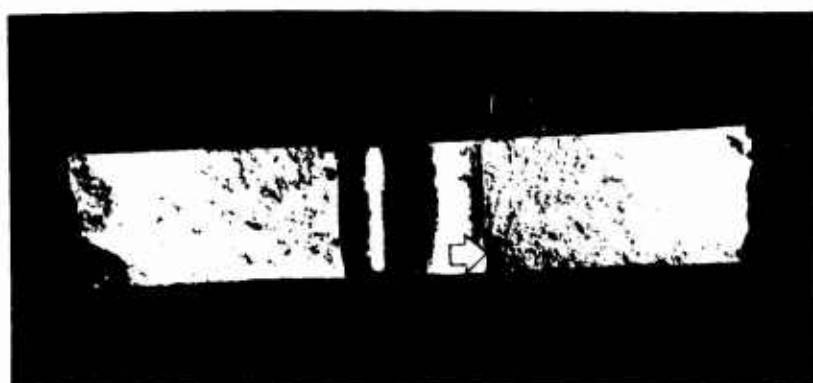
Figure 31 Specimen 28 - Task III
